## **Pre-Purchase Standard Property & Timber Pest Report**

**RBI BPI - RBI Pre-Purchase Standard Property & Timber Pest Report 2023  
Version. 3.0 | Standard Report**

**11 Jun 2024**

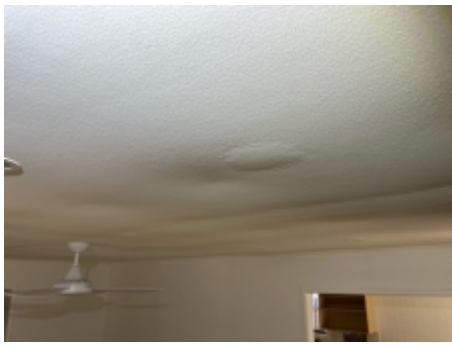
Cracking to ceiling and/or cornice - recommend engaging a plasterer to repair/replace as required to prevent further deterioration. The ceiling linings are showing signs of sagging or detachment from the supporting structure. Recommend engaging a plasterer to further investigate and conduct repairs as required to reduce the risk of further deterioration. (Garage)

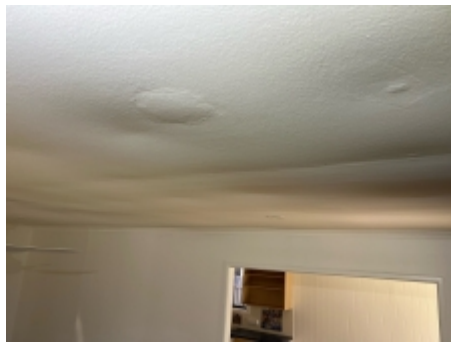
Cracking to ceiling and/or cornice - recommend engaging a plasterer to repair/replace as required to prevent further deterioration. The ceiling linings are showing signs of sagging or detachment from the supporting structure. Recommend engaging a plasterer to further investigate and conduct repairs as required to reduce the risk of further deterioration. (Garage)

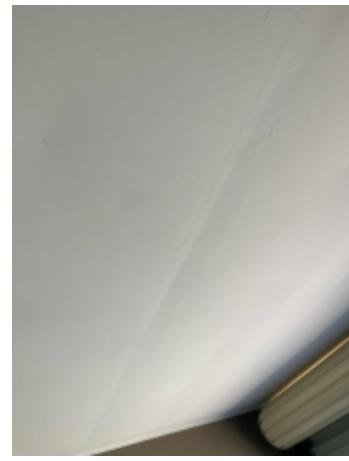
Cracking to ceiling and/or cornice - recommend engaging a plasterer to repair/replace as required to prevent further deterioration. The ceiling linings are showing signs of sagging or detachment from the supporting structure. Recommend engaging a plasterer to further investigate and conduct repairs as required to reduce the risk of further deterioration. (Garage)

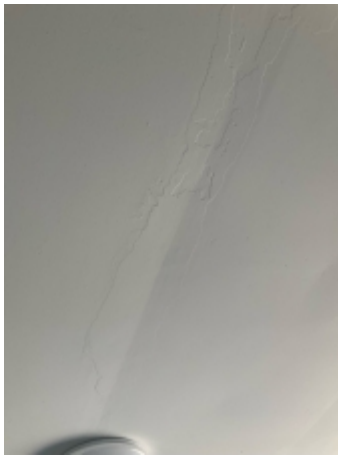
Cracking to ceiling and/or cornice - recommend engaging a plasterer to repair/replace as required to prevent further deterioration. The ceiling linings are showing signs of sagging or detachment from the supporting structure. Recommend engaging a plasterer to further investigate and conduct repairs as required to reduce the risk of further deterioration. (Garage)

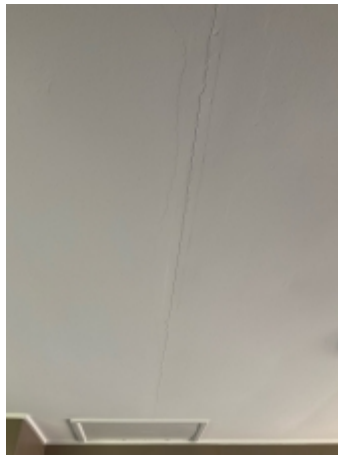
Cracking to ceiling and/or cornice - recommend engaging a plasterer to repair/replace as required to prevent further deterioration. The ceiling linings are showing signs of sagging or detachment from the supporting structure. Recommend engaging a plasterer to further investigate and conduct repairs as required to reduce the risk of further deterioration. (Garage)

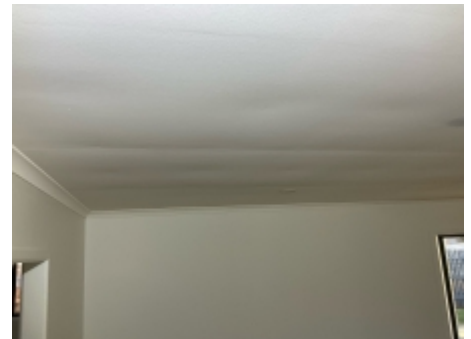
The ceiling linings are showing signs of sagging. Recommend engaging a plasterer to further investigate and conduct repairs as required to reduce the risk of further deterioration. (Living/ dining room, kitchen, bedrooms)

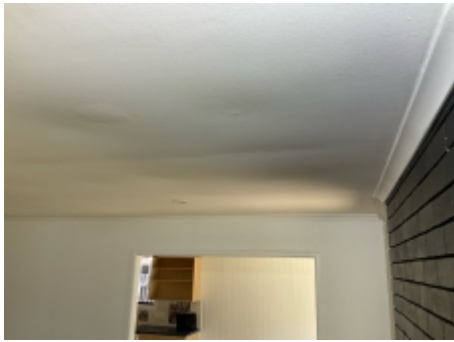
The ceiling linings are showing signs of sagging. Recommend engaging a plasterer to further investigate and conduct repairs as required to reduce the risk of further deterioration. (Living/ dining room, kitchen, bedrooms)

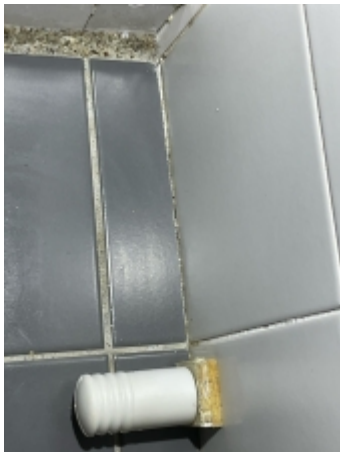
The sealants and/or grout to wet areas require repair where they are incomplete, defective, or no sealant or grout is installed. Recommend engaging a tiler or builder to rectify to reduce the risk of water penetration and further deterioration. (Wall/ floor connections to toilet and bathroom)

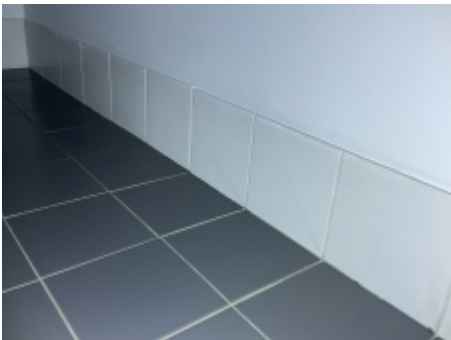
The sealants and/or grout to wet areas require repair where they are incomplete, defective, or no sealant or grout is installed. Recommend engaging a tiler or builder to rectify to reduce the risk of water penetration and further deterioration. (Wall/ floor connections to toilet and bathroom)

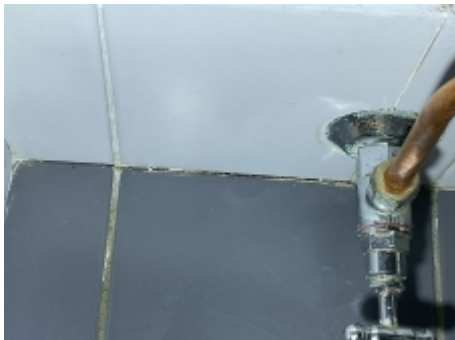
The sealants and/or grout to wet areas require repair where they are incomplete, defective, or no sealant or grout is installed. Recommend engaging a tiler or builder to rectify to reduce the risk of water penetration and further deterioration. (Wall/ floor connections to toilet and bathroom)

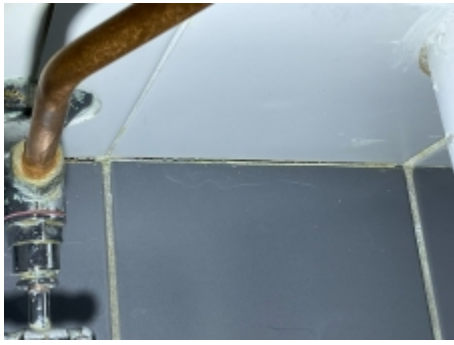
The sealants and/or grout to wet areas require repair where they are incomplete, defective, or no sealant or grout is installed. Recommend engaging a tiler or builder to rectify to reduce the risk of water penetration and further deterioration. (Wall/ floor connections to toilet and bathroom)

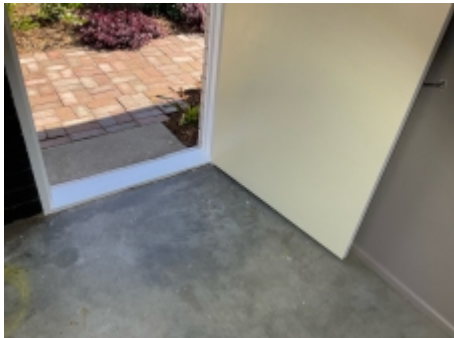
No weather seal fitted to door - recommend a carpenter to install a weather strip to prevent water penetration to the building (Rear garage door)

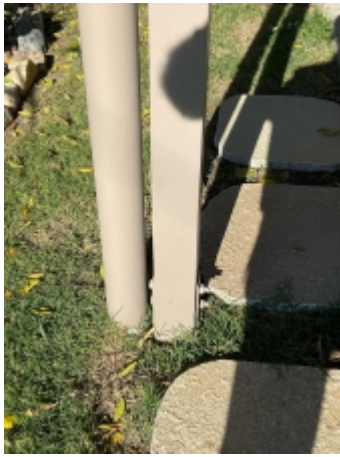
There are areas where timbers are in contact with or in close proximity to the ground. Where unsuitably untreated timbers or cladding is in close proximity to the ground, recommend engaging a carpenter to expose a minimum of 75mm between the timber and the ground to reduce the risk of deterioration and timber pest attack/damage. Timber posts to front and rear side of property.

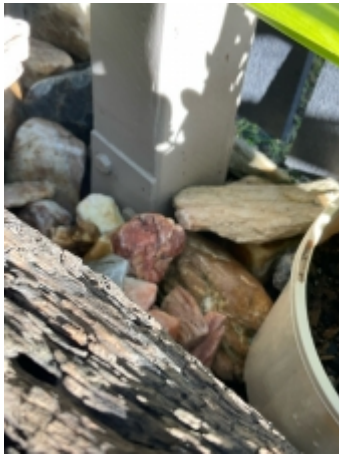
There are areas where timbers are in contact with or in close proximity to the ground. Where unsuitably untreated timbers or cladding is in close proximity to the ground, recommend engaging a carpenter to expose a minimum of 75mm between the timber and the ground to reduce the risk of deterioration and timber pest attack/damage. Timber posts to front and rear side of property.

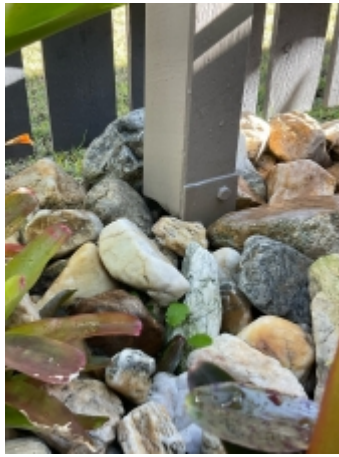
There are areas where timbers are in contact with or in close proximity to the ground. Where unsuitably untreated timbers or cladding is in close proximity to the ground, recommend engaging a carpenter to expose a minimum of 75mm between the timber and the ground to reduce the risk of deterioration and timber pest attack/damage. Timber posts to front and rear side of property.

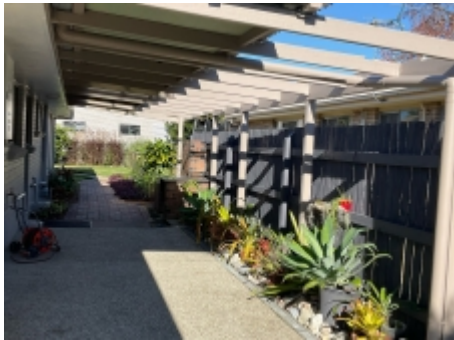
There are areas where timbers are in contact with or in close proximity to the ground. Where unsuitably untreated timbers or cladding is in close proximity to the ground, recommend engaging a carpenter to expose a minimum of 75mm between the timber and the ground to reduce the risk of deterioration and timber pest attack/damage. Timber posts to front and rear side of property.

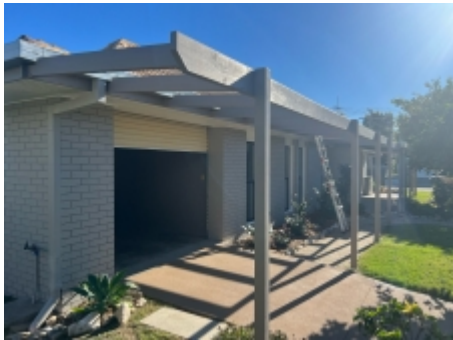
There are areas where timbers are in contact with or in close proximity to the ground. Where unsuitably untreated timbers or cladding is in close proximity to the ground, recommend engaging a carpenter to expose a minimum of 75mm between the timber and the ground to reduce the risk of deterioration and timber pest attack/damage. Timber posts to front and rear side of property.

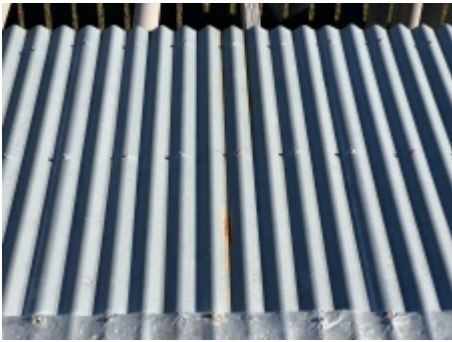
Rust to parts of the roof. Recommend engaging a roofer to repair/replace as required to prevent further deterioration and water penetration of the building. Rusting fixings or sheeting to the roof - recommend a roofing contractor/plumber to repair/replace fixings to reduce the risk of rust worsening and spreading (Rear side of property)

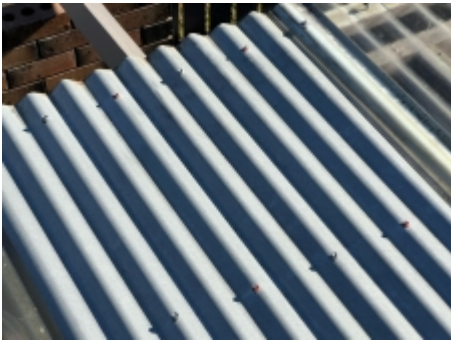
Rust to parts of the roof. Recommend engaging a roofer to repair/replace as required to prevent further deterioration and water penetration of the building. Rusting fixings or sheeting to the roof - recommend a roofing contractor/plumber to repair/replace fixings to reduce the risk of rust worsening and spreading (Rear side of property)

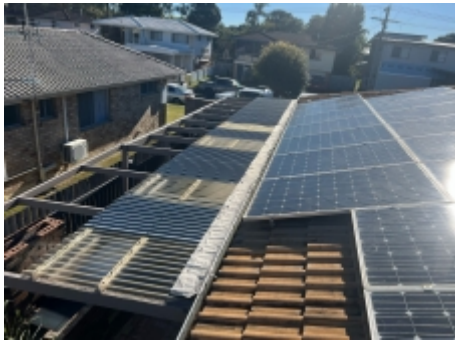
Rust to parts of the roof. Recommend engaging a roofer to repair/replace as required to prevent further deterioration and water penetration of the building. Rusting fixings or sheeting to the roof - recommend a roofing contractor/plumber to repair/replace fixings to reduce the risk of rust worsening and spreading (Rear side of property)

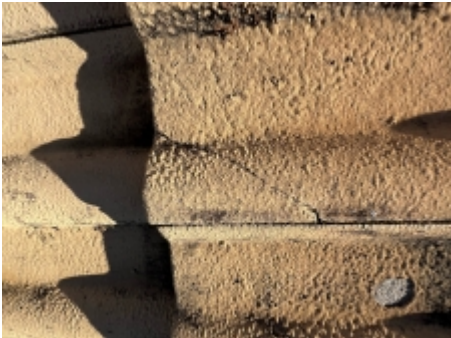
A few cracked or poorly repaired tiles. Recommend a roofing restoration contractor to repair/replace as required to reduce the risk of water leaks and damage.

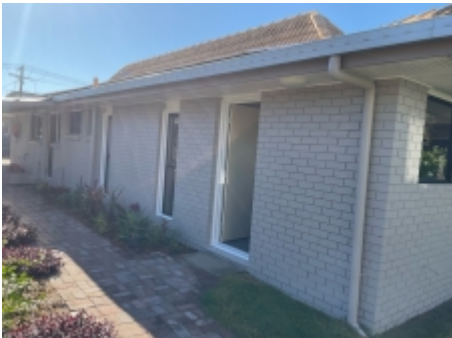
It appears that to long sides of property missing down pipes in middle. Recommend a roof plumber to inspect and install if required to reduce the risk of gutters overflow and moisture related issues

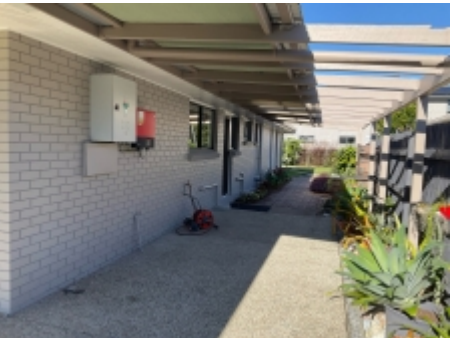
It appears that to long sides of property missing down pipes in middle. Recommend a roof plumber to inspect and install if required to reduce the risk of gutters overflow and moisture related issues

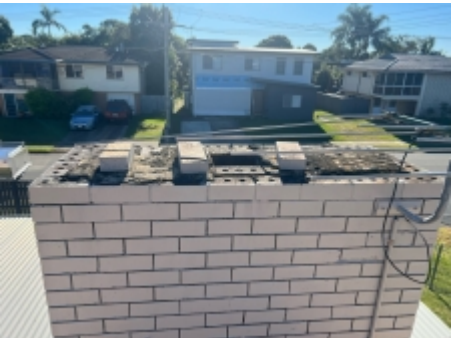
Showing missing flashing and cap over fireplace, recommend engaging a roofing contractor/ qualified tradesman to rectify to reduce the risk of moisture entry and damage

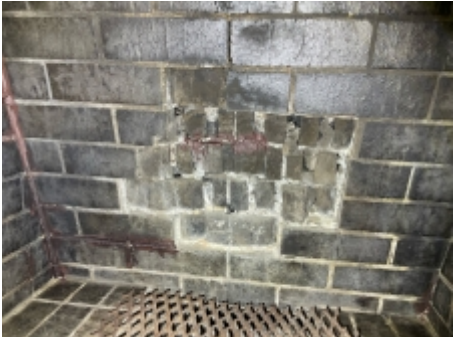
Showing damage to fire place brickwork

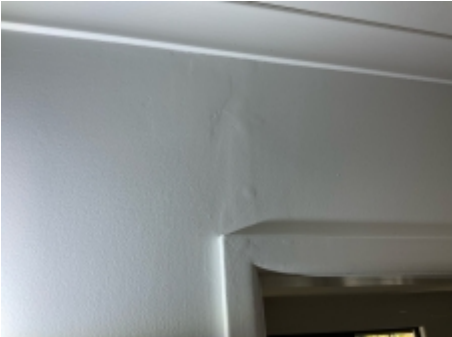
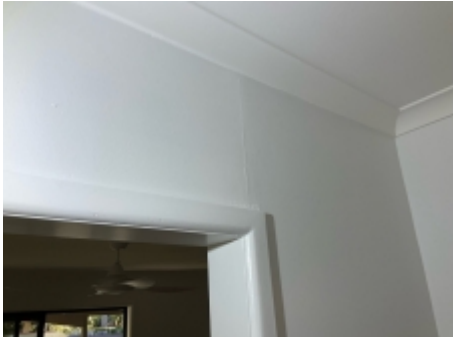
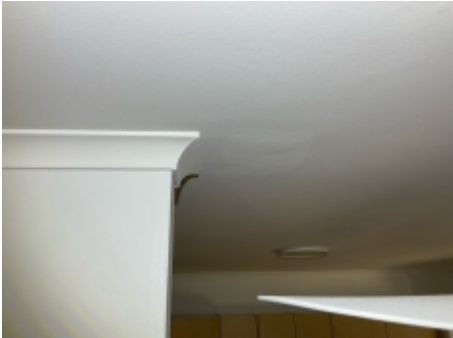
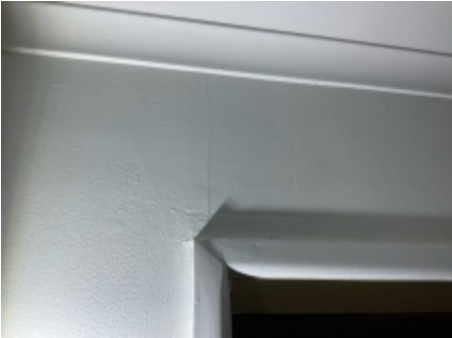
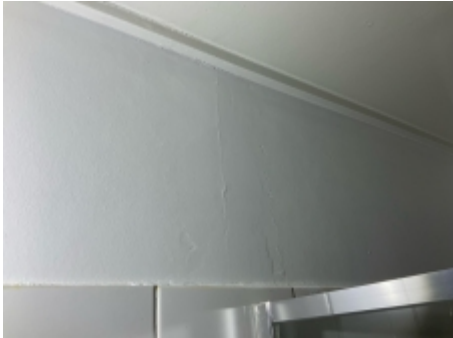
Showing examples of cracking to non-structural elements and paint/finishing defects

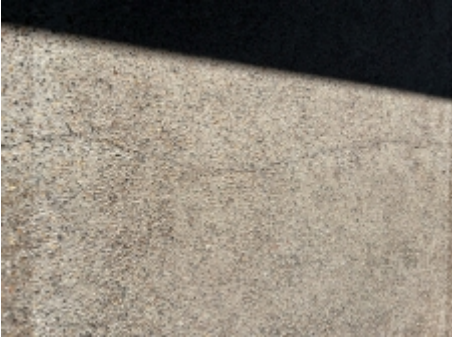
Showing examples of cracking to pathways throughout the property

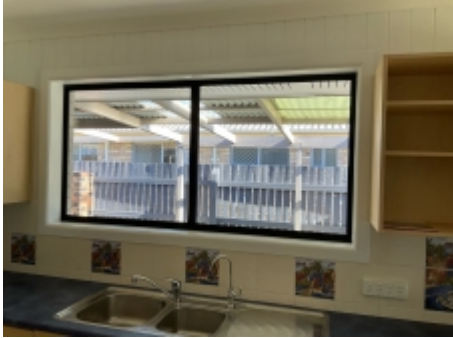
Showing example of windows requires maintenance to operate smoothly

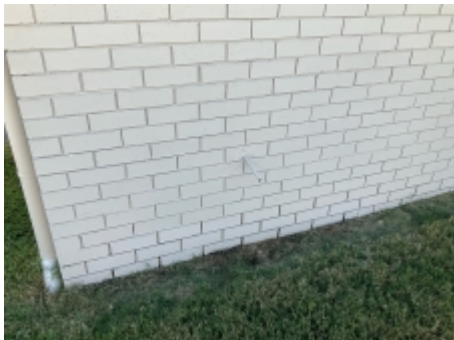
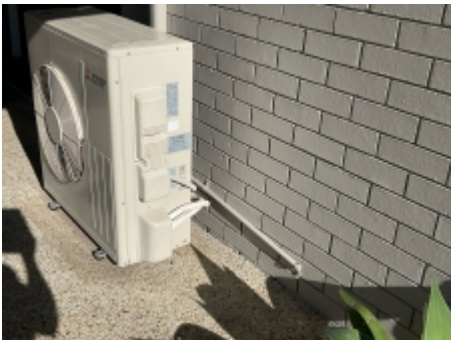
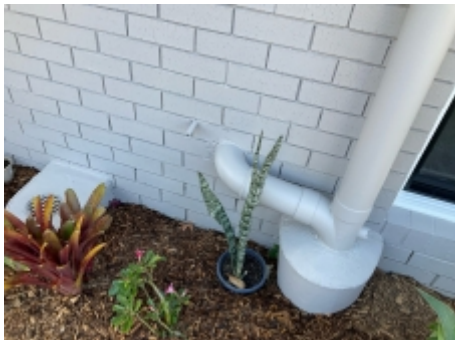
AC unit and Hot water system overflow/s, recommend diverting away from the building or to a suitable drain

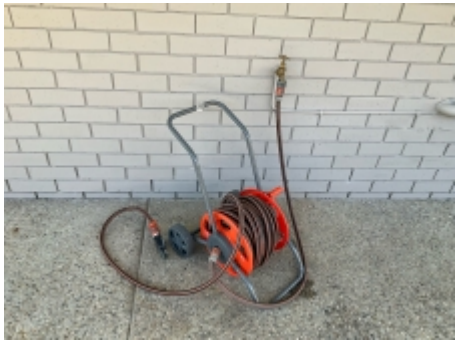
The external taps require a drain underneath them or a dispersion pad. Recommend a plumber to rectify

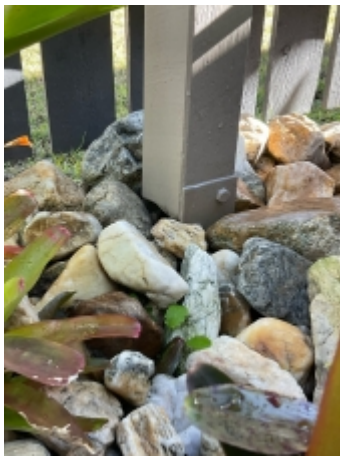
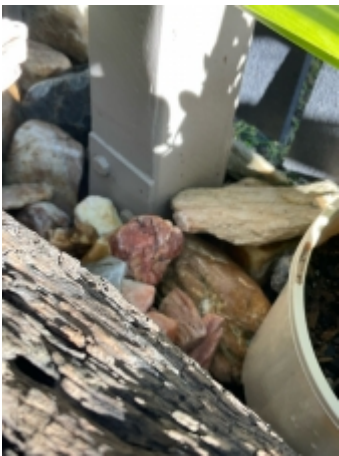
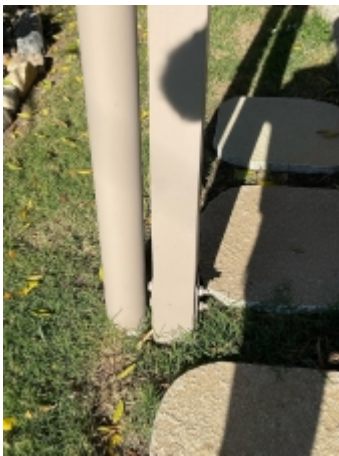
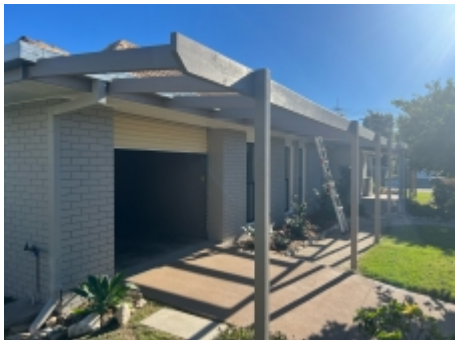
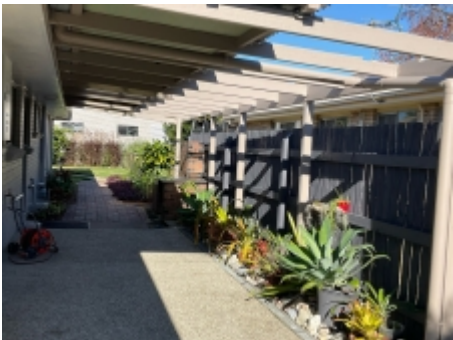
Timber/s in contact with ground - recommend exposing 75mm under timbers to allow for visual inspection zone and to prevent the risk of wood rot and termite attack
