## **Pre-Purchase Standard Property & Timber Pest Report**

**RBI BPI - RBI Pre-Purchase Standard Property & Timber Pest Report 2023  
Version. 3.0 | Standard Report**

**11 Jun 2024**

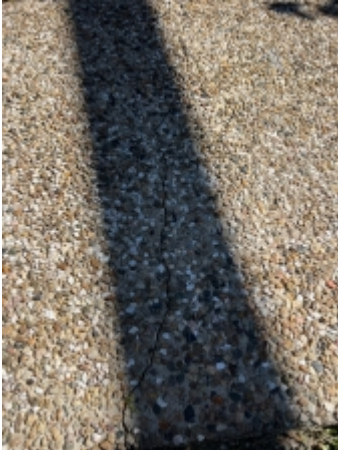
Showing examples of cracking to pathways throughout the property

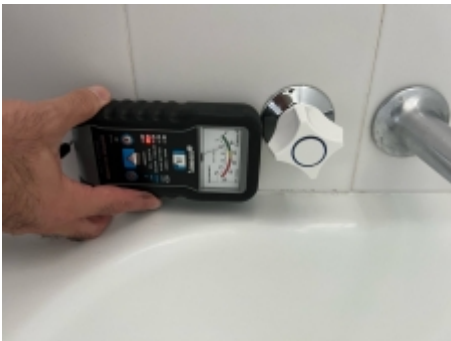
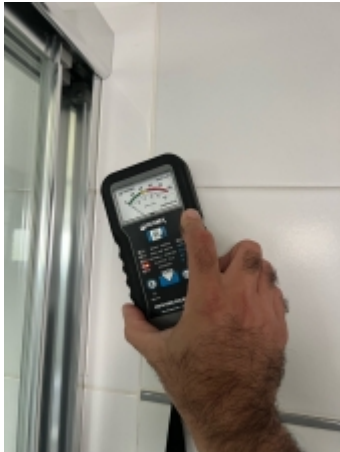
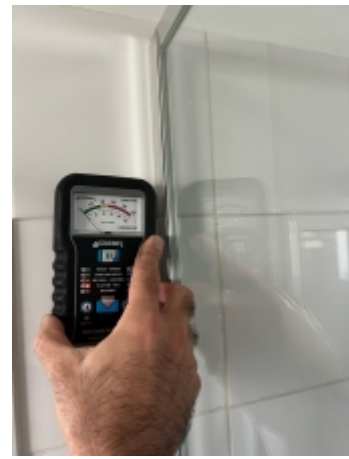
Showing examples of moisture meter readings taken on site, where the level recorded did not show an elevated reading.
