## **Pre-Purchase Standard Property & Timber Pest Report**

**RBI BPI - RBI Pre-Purchase Standard Property & Timber Pest Report 2023  
Version. 3.0 | Standard Report**

**11 Jun 2024**

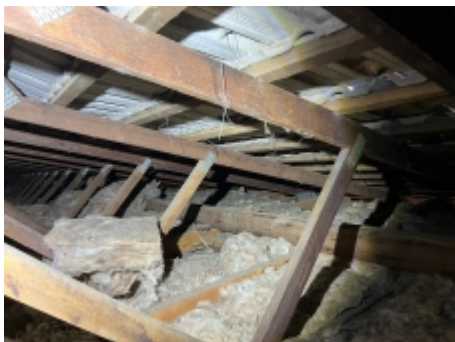
Showing example of framing and low clearance in the roof space

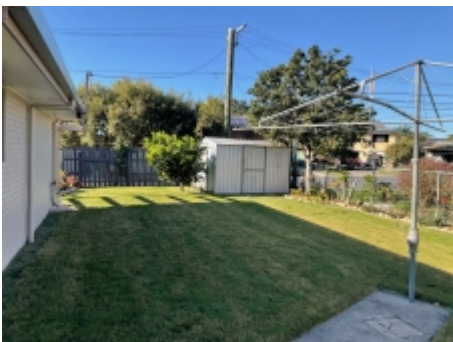
Showing example of landscaping and gardens

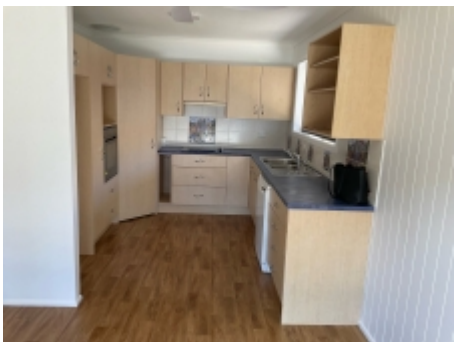
Showing example of the cabinetry

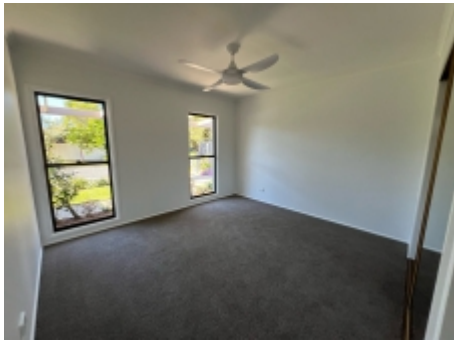
Showing example of wall, floor and ceiling coverings

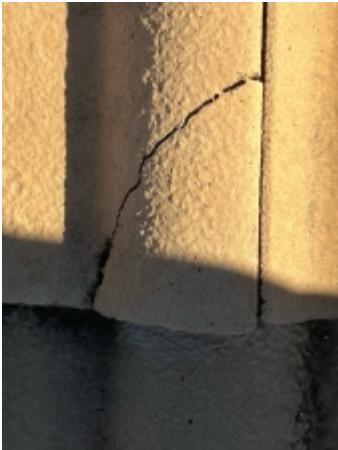
A few cracked or poorly repaired tiles. Recommend a roofing restoration contractor to repair/replace as required to reduce the risk of water leaks and damage.

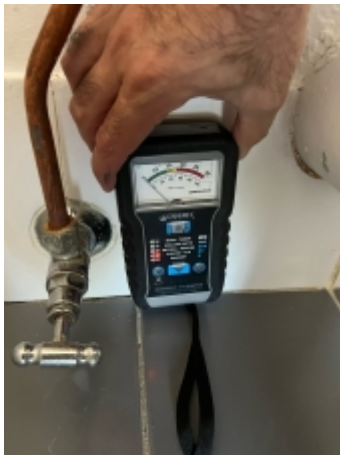
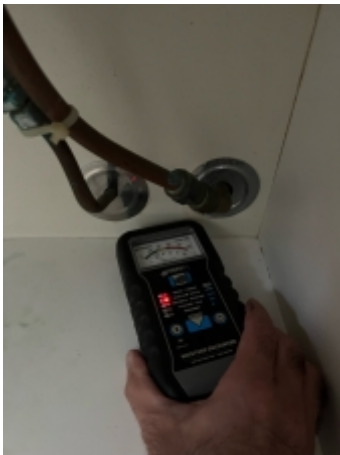
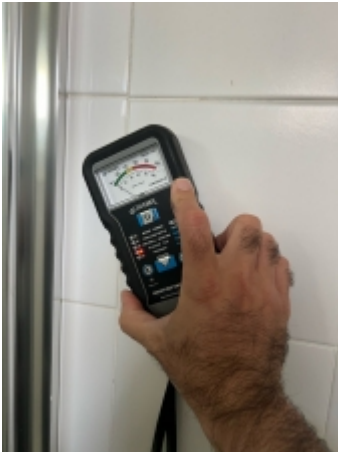
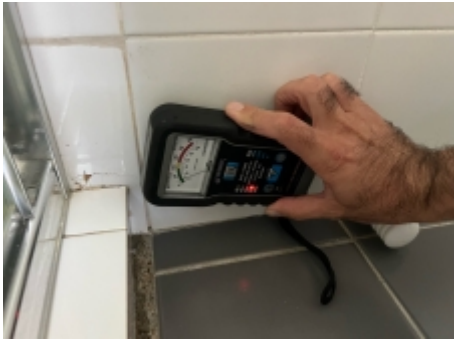
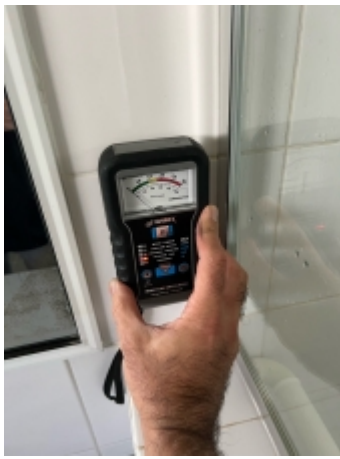
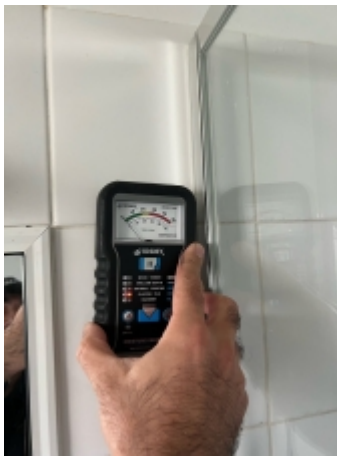
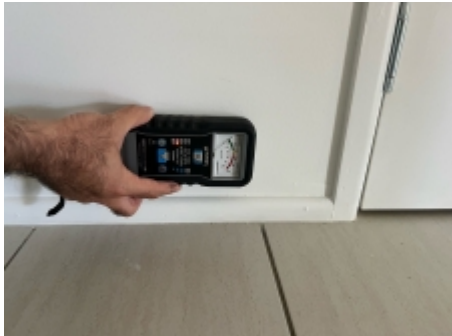
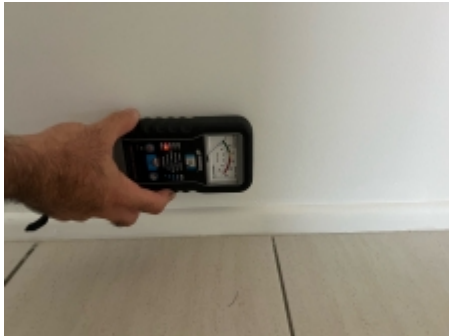
Showing examples of moisture meter readings taken on site, where the level recorded did not show an elevated reading.
